H-43B PRACTICE AUTOROTATION

H-21 DEMOLISHED AT INADEQUATE LANDING PAD

the MATS flyer

Wind . . .

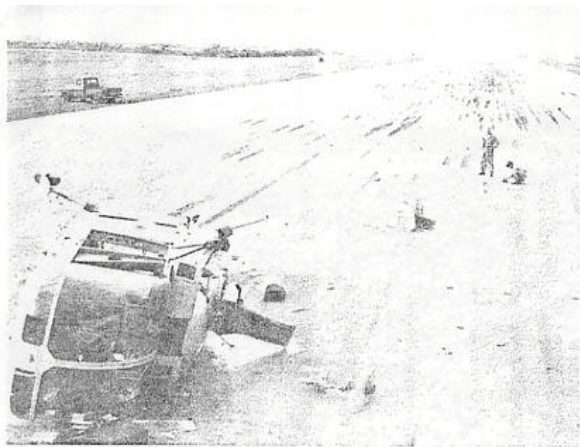
Complete writeoff of H-43B helicopter resulted when wind shifted to a quartering tail wind component and chopper hit hard, left gear first. Fortunately, crew escaped injury with the pilot's life being saved by crash helmet.

- The left auxiliary landing gear failed at the axle fork and the bear paw broke loose from the strut assembly.
- Both tail booms broke at the fuselage attachment points, and the fuselage came to rest on its left side, 180 degrees from its original heading.
- Both rotor systems disintegrated, the blades scattering and traveling distances up to 600 feet.
- All four occupants evacuated the aircraft successfully and the wreckage did not burn.

Why did this transition flight come to such an abrupt end when being conducted under VFR conditions by competent crew? The accident investigation determined the primary cause to be that the instructor pilot did not monitor wind direction and attempted the autorotation with a quartering tail wind which increased settling inertia. Unable to correct at the last moment, his aircraft struck the ground in a skid which failed the gear.

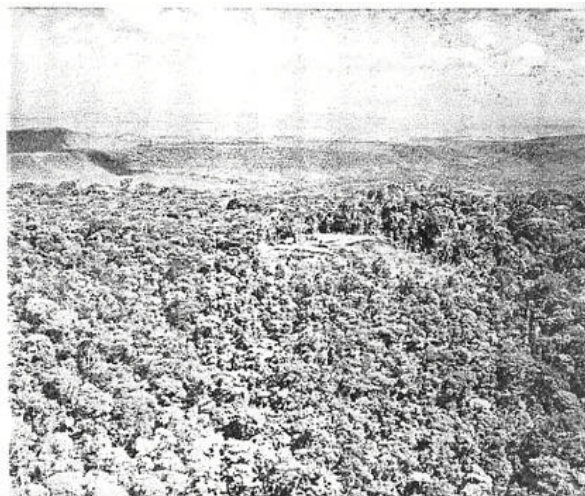
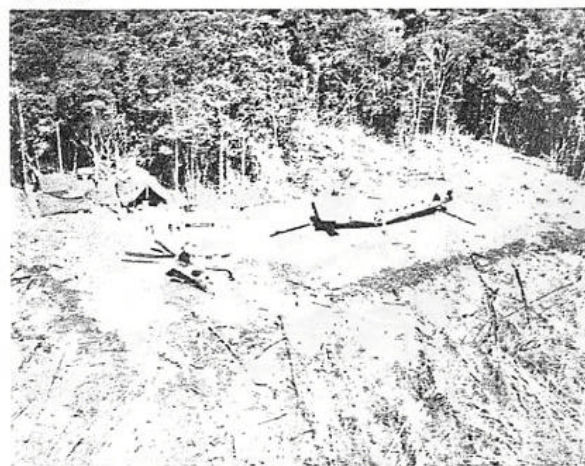
- Collapse of the left main gear ruptured the firewall and main fuel cell, and the aircraft was destroyed by fire.

The aircraft was caught either by a sudden shift in wind or by total loss of wind. Subsequent wind measurement — something not tried before the accident — determined that both direction and speed of wind change rapidly and constantly due to the terrain features. *Primary cause was found to be inadequacy of the landing pad surface, made hazardous by the presence of stumps and large stones.*

Contributing factors were weather conditions in that winds, constantly changing in velocity and direction, were not made available to the pilot; supervisory in that the pad was not adequately cleared, a wind sock was not installed, specific touchdown area was not marked, smoke grenades were not available to indicate wind, and a safety survey had not previously been made of the landing area.

Aerial views of jungle landing pad which was clearly hazardous enough without being complicated by improperly cleared tree stumps and lack of wind sock. Crew escaped serious injury but H-21 was completely destroyed in accident.

Recommendations of the accident investigation board were that this particular landing pad be improved, that criteria be established for H-21 landing pads in this area, and that newly assigned pilots on this project complete a 90 day tour as copilot before being upgraded. It also was noted that ground personnel had not been indoctrinated in proper methods of assisting the chopper crew with the approach, and suggestion was made that ground parties at the sites be provided with material to assist helicopter landings. An IP later stated he hadn't realized how valuable a wind sock would be at this site until he had landed there himself several times after the
