H-43B PRACTICE AUTOROTATION

H-21 DEMOLISHED AT INADEQUATE LANDING PAD

the MATS flyer

Wind . . .

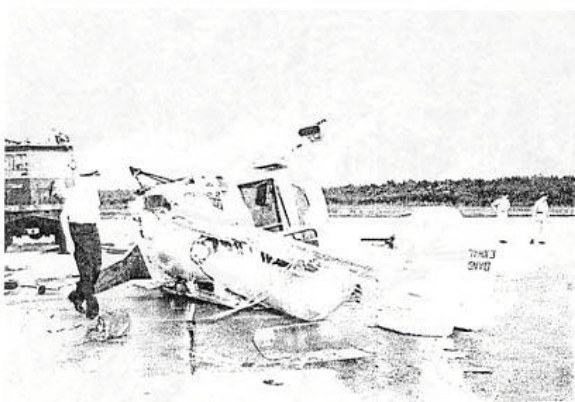
Complete writeoff of H-43B helicopter resulted when wind shifted to a quartering tail wind component and chopper hit hard, left gear first. Fortunately, crew escaped injury with the pilot's life being saved by crash helmet.

- The left auxiliary landing gear failed at the axle fork and the bear paw broke loose from the strut assembly.
- Both tail booms broke at the fuselage attachment points, and the fuselage came to rest on its left side, 180 degrees from its original heading.
- Both rotor systems disintegrated, the blades scattering and traveling distances up to 600 feet.
- All four occupants evacuated the aircraft successfully and the wreckage did not burn.

Why did this transition flight come to such an abrupt end when being conducted under VFR conditions by competent crew? The accident investigation determined the primary cause to be that the instructor pilot did not monitor wind direction and attempted the autorotation with a quartering tail wind which increased settling inertia. Unable to correct at the last moment, his aircraft struck the ground in a skid which failed the gear.
